Facility Condition Assessment

North Providence - Marieville Elementary School

June 2017

1135 Mineral Spring Avenue, North Providence, RI 02904

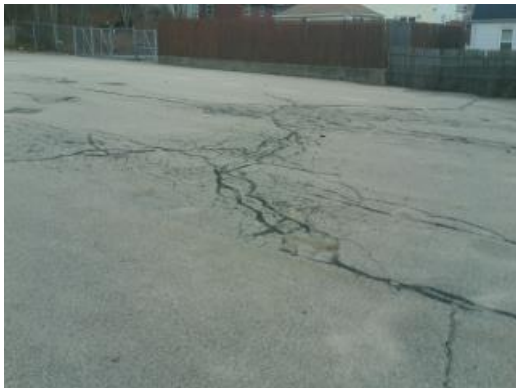
Cracked Asphalt Paving

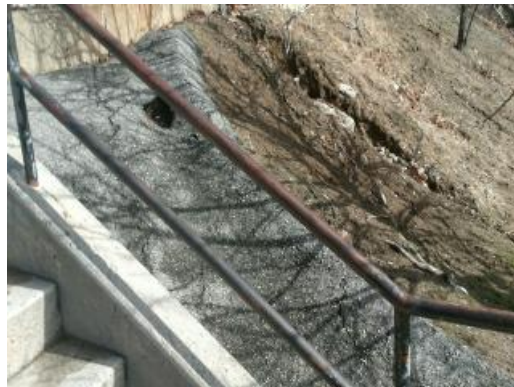
Deficiency	Category	Qty	UoM	Priority	Repair Cost	ID
Handrail Requires Replacement	Capital Renewal	40	LF	3	\$7,589	372
Note: Railing on stairway from upper parking level to paved play area is rusted & worn						
Sub Total for System		1	items		\$7,589

Rusted & Worn Stairwell Railing

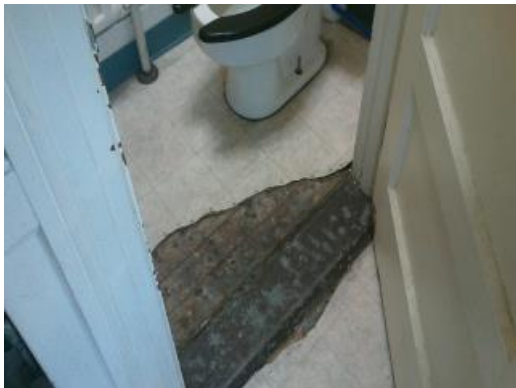
VCT Tile Damage In Faculty Restroom

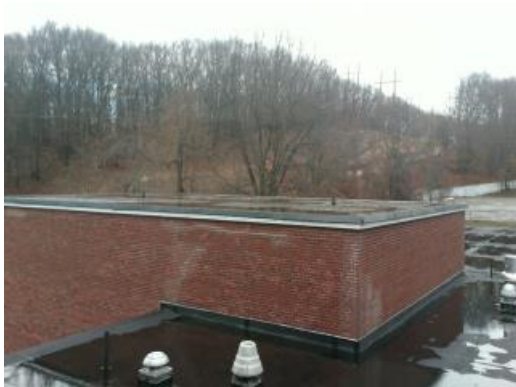
Deficiency	Category	Qty	UoM	Priority	Repair Cost	ID
Roof Drainage Piping Requires Repair	Capital Renewal	30	LF	3	\$6,943	370
Note: PVC pipes providing roof drainage cause water pooling & icy conditions in cold weather						
The Plumbing / Domestic Water Piping System Is Beyond Its Useful Life	Capital Renewal	28,210	SF	3	\$248,885	329
The Sanitary Sewer Piping Requires Replacement	Capital Renewal	750	LF	3	\$128,036	330
The Urinal Plumbing Fixtures Require Replacement	Capital Renewal	12	Ea.	3	\$17,488	337
Non-Refrigerated Drinking Fountain Requires Replacement	Capital Renewal	1	Ea.	4	\$11,207	268
The Classroom Lavatories Plumbing Fixtures Require Replacement	Capital Renewal	13	Ea.	4	\$38,759	336
The Restroom Lavatories Plumbing Fixtures Require Replacement	Capital Renewal	9	Ea.	4	\$31,393	340
Room lacks a drinking fountain.	Educational Adequacy	16	Ea.	5	\$17,860	Rollup
The Class Room Lavatories Plumbing Fixtures Are Missing And Should Be Installed	Educational Adequacy	16	Ea.	5	\$17,485	Rollup

Roof Ponding - Gym Area

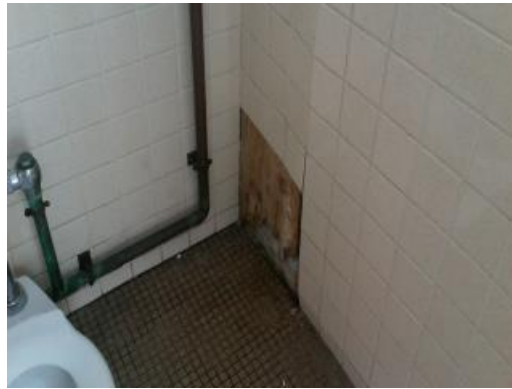
Damaged Tile Wall In Boys Restroom

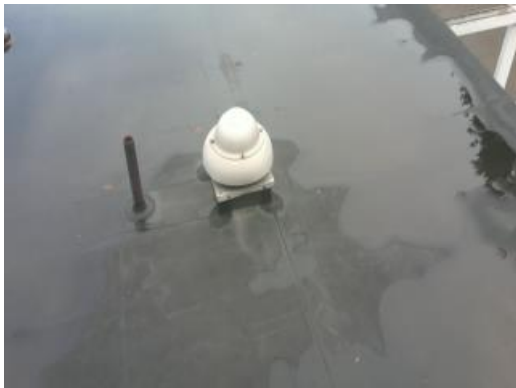
Small Roof Exhaust And Roof Ponding

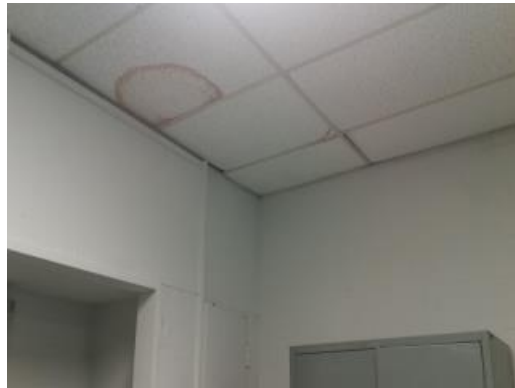
Deficiency	Category	Qty	UoM	Priority	Repair Cost	ID
Classroom Entry Doors Provide Insufficient Sound Isolation	Acoustics	16	Ea.	3	\$146,029	4702
Note: All classroom						
The Acoustical Ceiling Tiles Require Replacement	Capital Renewal	23,000	SF	3	\$227,780	344
Note: Ceiling tile is in need of replacement due to staining and potential mold/mildew issues						
The Carpet Flooring Requires Replacement	Capital Renewal	200	SF	3	\$4,771	314
Note: Carpet in copy room is beyond its useful lifespan and should be replaced						
9x9 Asbestos Tile Present and In Active Use, Greater than 25 Percent has Significant Deterioration	Hazardous Material	24,590	SF	4	\$769,030	Rollup
Caulking - significant areas of broken pieces &/or deteriorating caulk	Hazardous Material	120	LF	4	\$2,502	Rollup
Ceiling Grid Requires Replacement	Capital Renewal	23,000	SF	4	\$299,125	394
Note: Aged, warping, & showing signs of potential leakage

Stained Ceiling Tile

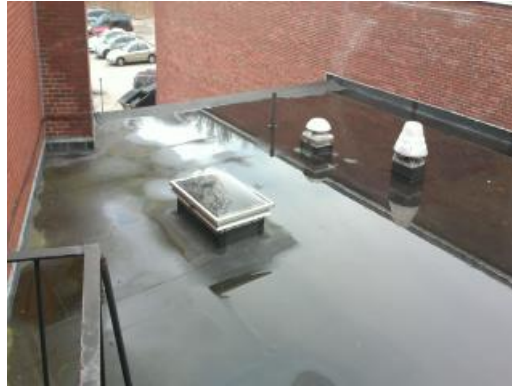
Ponding On Roof

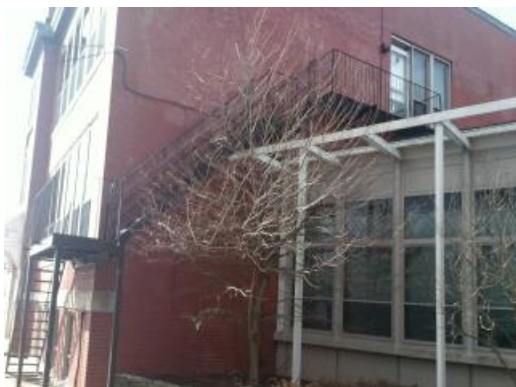
Deficiency	Category	Qty	UoM	Priority	Repair Cost	ID
Fire Escape Requires Replacement	Functional Deficiency	2	Ea.	1	\$25,019	368
Note: Fire escapes do not all reach ground level and are not properly secured within classrooms						
Fire Sprinkler System Requires Replacement (SF Basis) per NFPA 13	Capital Renewal	28,210	SF	1	\$588,162	321
	Sub Total for System	2	items		\$613,181

Fire Escape From Second Level
