# Facility Condition Assessment

Warwick - E. G. Robertson School

June 2017

70 Nausauket Road, Warwick, RI 02886

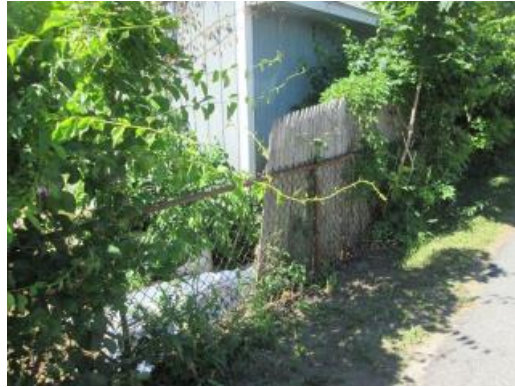
Rusted Fencing

Backstops Require Replacement <b>Note:</b> Backstops Require Replacement	Educational Adequacy	1	Ea.	4	\$36,840	28604
Fencing Requires Replacement (4' Chain Link Fence) <b>Note:</b> The fencing is rusted.	Capital Renewal	400	LF	4	\$33,401	17814
Site Marquee Requires Repair	Capital Renewal	1	Ea.	5	\$4,396	17819
<b>Sub Total for System</b>		<b>10</b>	<b>items</b>		<b>\$893,875</b>

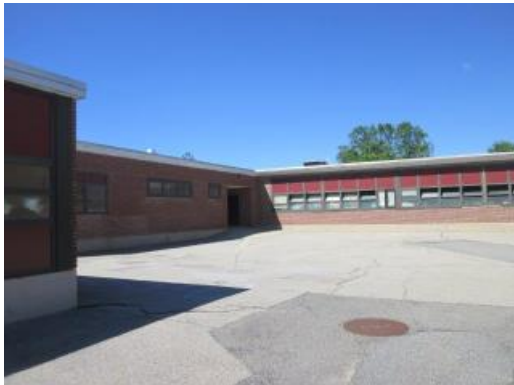
Paved Play Area

Deficiency	Category	Qty	UoM	Priority	Repair Cost	ID
Asphalt Walks Require Replacement <b>Note:</b> The paved play area is deteriorated.	Capital Renewal	17,000	SF	3	\$187,641	17817
Concrete Walks Require Replacement <b>Note:</b> The concrete sidewalks are rough and deteriorating.	Capital Renewal	1,100	SF	3	\$29,041	17818
Crosswalk Requires Repainting <b>Note:</b> Repaint crosswalks on campus	Traffic	3	Ea.	3	\$2,947	22040
Pavement Markings: Words/Symbols Are Required <b>Note:</b> Repaint arrow symbols on campus	Traffic	3	Ea.	3	\$1,474	22041
The Playground Impact Surface Does Not Meet ADA Guidelines For Accessible Play Surfaces	Barrier to Accessibility	6,000	SQFT	3	\$294,716	17820
Asphalt Paving Requires Replacement <b>Note:</b> The front and side roadway pavement is in poor condition.	Capital Renewal	28	CAR	4	\$119,658	17815
Asphalt Paving Requires Replacement <b>Note:</b> The parking lot pavement adjacent to the multipurpose addition is in poor condition.	Capital Renewal	43	CAR	4	\$183,761	17816

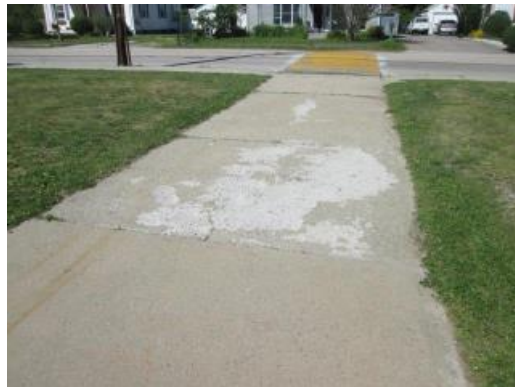
Spalled Sidewalks

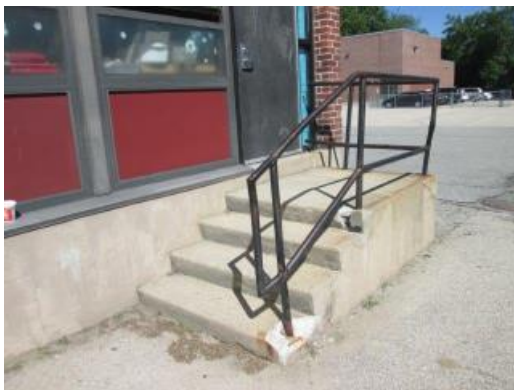
Damaged Exterior Stair Railing

Deficiency	Category	Qty	UoM	Priority	Repair Cost	ID
Handrail Requires Replacement <b>Note:</b> The exit stair railing at the east classroom wing exit is damaged.	Capital Renewal	12	LF	3	\$2,682	17821
<b>Sub Total for System</b>		<b>1</b>	<b>items</b>		<b>\$2,682</b>	
<b>Sub Total for School and Site Level</b>		<b>11</b>	<b>items</b>		<b>\$896,557</b>

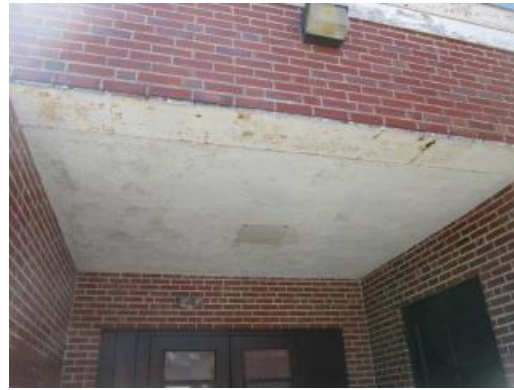
Worn Soffit Paint

Deficiency	Category	Qty	UoM	Priority	Repair Cost	ID
The Overhead Door Requires Replacement <b>Note:</b> Rolling gates at main corridor to close off the two classroom wings when the auditorium is in use after school hours. 2 gates at 9 ft x 9 ft.	Capital Renewal	2	Door	2	\$79,716	17851
The Wood Exterior Door Requires Replacement <b>Note:</b> The original exterior wood doors are deteriorated.	Capital Renewal	12	Door	2	\$108,204	17824
The Wood Window Requires Replacement <b>Note:</b> The original wood windows are in poor condition.	Capital Renewal	66	SF	2	\$13,652	17825
The Exterior Requires Painting <b>Note:</b> The exterior painted wood trim is in poor condition. <b>Location:</b> Main building wood trim below roof line	Capital Renewal	1,320	SF Wall	5	\$7,872	17823
The Exterior Soffit Requires Repainting <b>Note:</b> The exterior soffits are in poor condition.	Capital Renewal	800	SF	5	\$2,884	17822

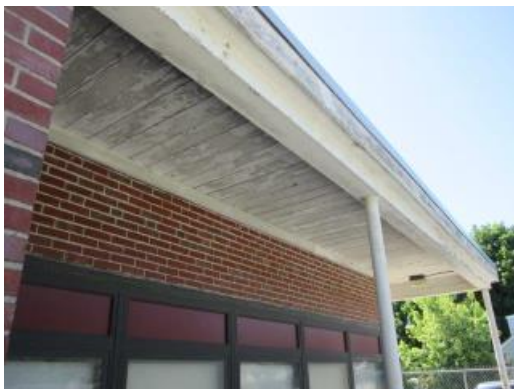
Soffit Paint

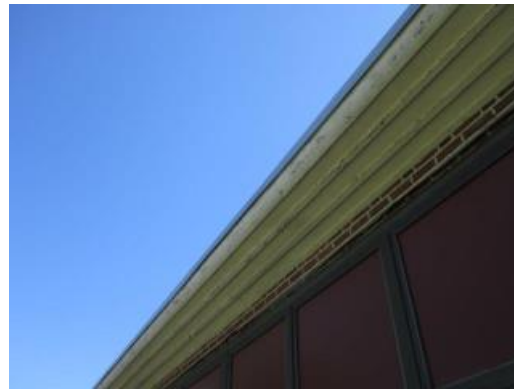
Painted Wood Trim

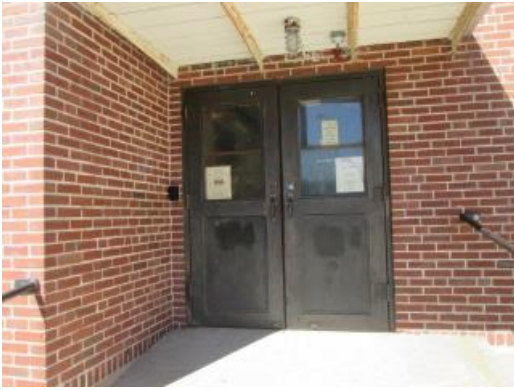
Original Exterior Wood Doors

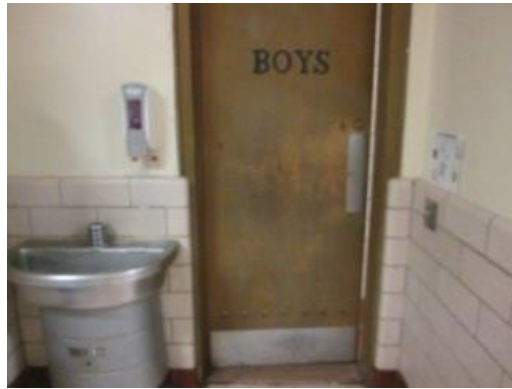
Worn Interior Wood Door

Deficiency	Category	Qty	UoM	Priority	Repair Cost	ID
Classroom Entry Doors Provide Insufficient Sound Isolation <b>Note:</b> Older Classroom Doors	Acoustics	12	Ea.	3	\$108,204	27803
Interior Doors Require Replacement <b>Note:</b> The interior wood doors are aged and worn.	Capital Renewal	58	Door	3	\$289,717	17828
The Acoustical Ceiling Tiles Require Replacement <b>Note:</b> Ceiling tiles are in poor condition.	Capital Renewal	4,900	SF	3	\$47,943	17827
The Ceramic Tile Flooring Requires Replacement <b>Note:</b> The ceramic tile flooring is in poor condition.	Capital Renewal	300	SF	3	\$8,727	17830
The Wood Flooring Requires Replacement <b>Note:</b> The wood flooring at the stage is in poor condition.	Capital Renewal	800	SF	3	\$28,755	17829
Adhered Acoustical Ceiling Tile Requires Replacement <b>Note:</b> The adhered tile ceilings are in poor condition.	Capital Renewal	16,484	SF	4	\$193,647	17850
Ceiling Grid Requires Replacement	Capital Renewal	4,900	SF	4	\$62,959	17849

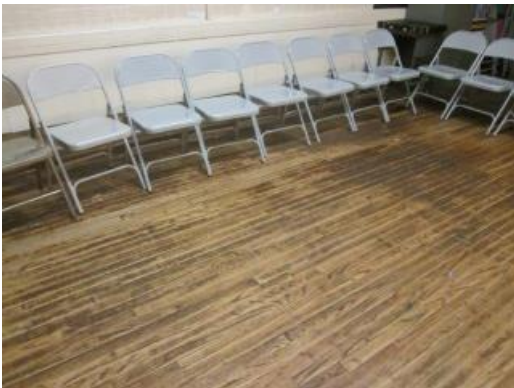
Worn Wood Stage Floor

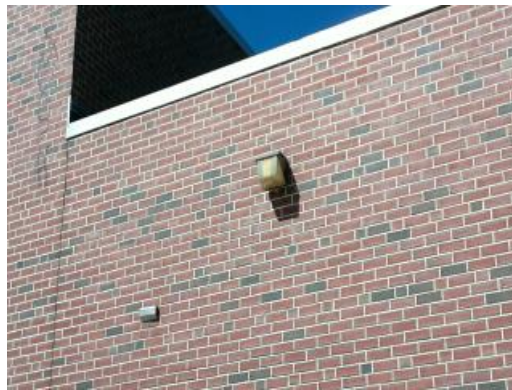
Aged Building Mounted Light

Uniformat Description	LC Type Description	Qty	UoM	Repair Cost	Remaining Life
Lighting Fixtures	Canopy Mounted Fixtures (Ea.)	3	Ea.	\$4,136	4
Lighting Fixtures	Building Mounted Fixtures (Ea.)	6	Ea.	\$8,956	4
<b>Sub Total for System</b>		<b>2</b>	<b>items</b>	<b>\$13,091</b>

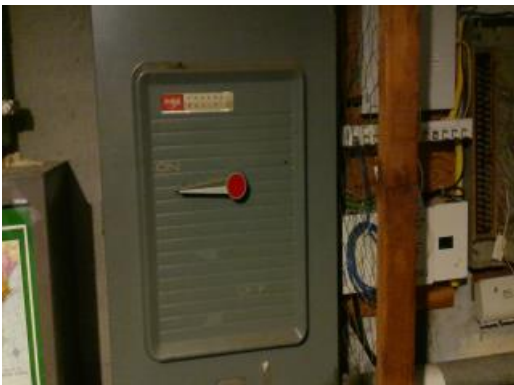
Federal Pacific Disconnect

Deficiency	Category	Qty	UoM	Priority	Repair Cost	ID
The Electrical Disconnect Requires Replacement <b>Note:</b> The Federal Pacific disconnect is old, in poor condition, and needs to be replaced.	Capital Renewal	1	Ea.	2	\$1,986	17833
The Lighting Fixtures Require Replacement <b>Note:</b> Lights are old and inefficient.	Capital Renewal	38,674	SF	2	\$248,945	17845
The Panelboard Requires Replacement <b>Note:</b> Panels are old and in poor condition. They should be replaced to reduce the risk of breakers failing.	Capital Renewal	2	Ea.	2	\$20,804	17840

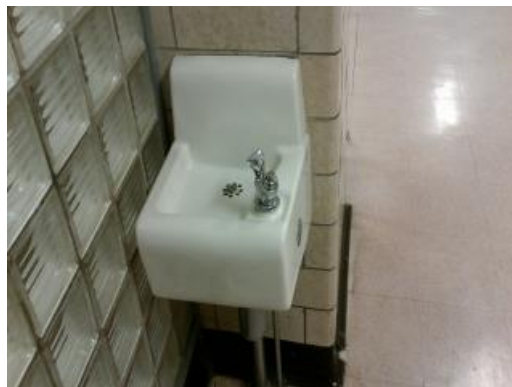
Aged Water Fountain

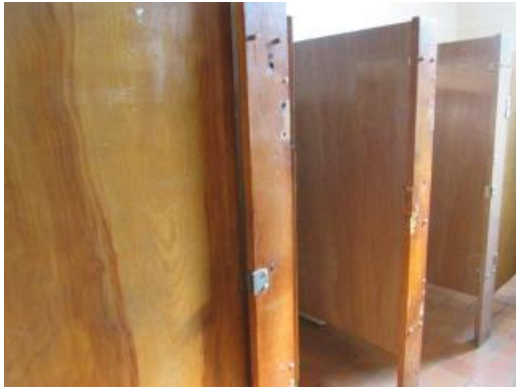
Damaged Toilet Partitions

Interior Toilet Partition Requires Repair <b>Note:</b> The toilet partitions are in poor condition.	Capital Renewal	20	Ea.	4	\$11,329	17838
Paint (probable pre-1978 in base layer(s)) - damaged area < 9 sq. ft. OR overall worn AND in children-accessible area (measurement unit - each)	Hazardous Material	15	Ea.	4	\$4,635	Rollup
Paint (probable pre-1978 in base layer(s)) - damaged area < 9 sq. ft. OR overall worn AND in children-accessible area (measurement unit - linear feet)	Hazardous Material	1,910	LF	4	\$47,212	Rollup
Paint (probable pre-1978 in base layer(s)) - damaged area < 9 sq. ft. OR overall worn AND in children-accessible area (measurement unit - square feet)	Hazardous Material	100	SF	4	\$1,030	Rollup
Room Is Excessively Reverberant <b>Note:</b> Gym	Acoustics	1,500	SF	4	\$36,305	27804
Room Is Excessively Reverberant <b>Note:</b> Music Space	Acoustics	600	SF	4	\$14,522	27805
Room Lighting Is Inadequate Or In Poor Condition.	Educational Adequacy	2,277	SF	4	\$86,763	Rollup

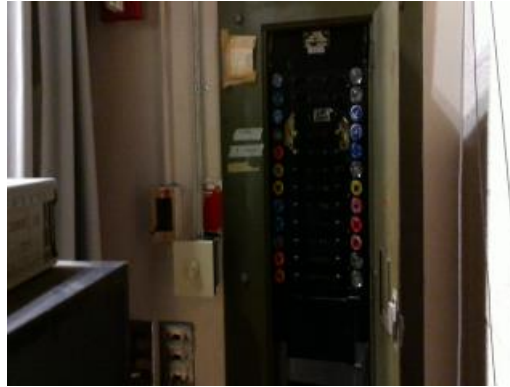
Aged Panelboard

Deficiency	Category	Qty	UoM	Priority	Repair Cost	ID
The Panelboard Requires Replacement <b>Note:</b> Main distribution panel is old and in poor condition.	Capital Renewal	1	Ea.	2	\$12,390	17841
The Panelboard Requires Replacement <b>Note:</b> Panels are old and in poor condition. They should be replaced to reduce the risk of breakers failing.	Capital Renewal	6	Ea.	2	\$37,695	17842
The Mounted Building Lighting Requires Replacement <b>Note:</b> Lights are old and do not illuminate well.	Capital Renewal	15	Ea.	3	\$24,255	17832
Room Has Insufficient Electrical Outlets	Educational Adequacy	88	Ea.	5	\$43,671	Rollup
<b>Sub Total for System</b>		<b>7</b>	<b>items</b>		<b>\$389,746</b>

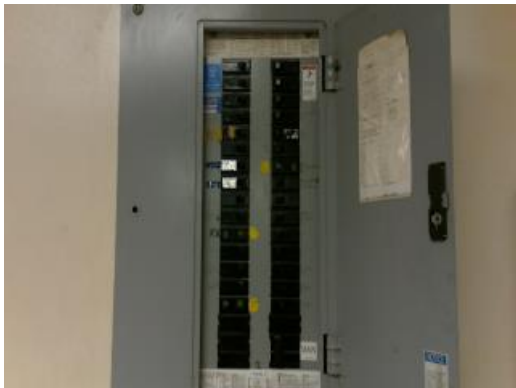
100 Amp Panelboard

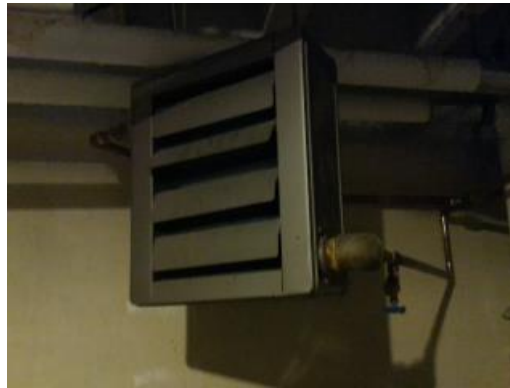
Unit Heater

Deficiency	Category	Qty	UoM	Priority	Repair Cost	ID
Replace Unit Vent <b>Note:</b> Per LEA review feedback the district believes the heating system needs to be replaced.	Capital Renewal	8	Ea.	2	\$140,957	53609
Steam/HW Unit Heater Requires Replacement <b>Note:</b> Unit heater in the electrical room is old and in poor condition.	Capital Renewal	1	Ea.	2	\$2,587	17843
The Cast Iron Water Boiler Requires Replacement <b>Note:</b> Boiler is old, rusted, and corroded.	Capital Renewal	1	Ea.	2	\$196,093	17844
The Fin Tube Water Radiant Heater Requires Replacement <b>Note:</b> Per LEA review feedback the district believes the heating system needs to be replaced.	Capital Renewal	99	Ea.	2	\$179,657	53608
Existing Controls Are Inadequate And Should Be Replaced With DDC Controls <b>Note:</b> Control system needs to be upgraded to DDC. Current system results in uneven heating throughout the building.	Capital Renewal	38,674	SF	4	\$283,001	17846

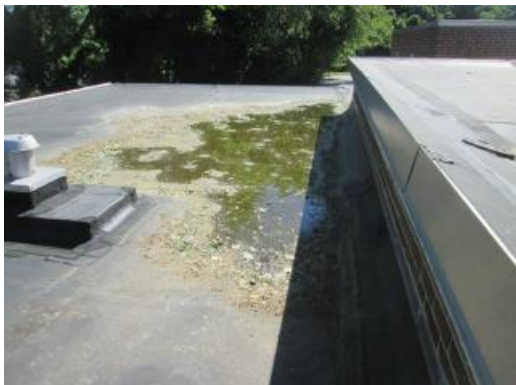
Main Building Roof

Deficiency	Category	Qty	UoM	Priority	Repair Cost	ID
EPDM Roofing Requires Replacement (Bldg SF) <b>Note:</b> The roofing is in poor condition.	Capital Renewal	35,394	SF	2	\$484,826	17847
The Single-Ply Membrane Roof Covering Requires Replacement <b>Note:</b> The ballasted single ply roof at the multipurpose addition is in poor condition.	Capital Renewal	3,280	SF	2	\$135,126	17826
<b>Sub Total for System</b>		<b>2</b>	<b>items</b>		<b>\$619,951</b>

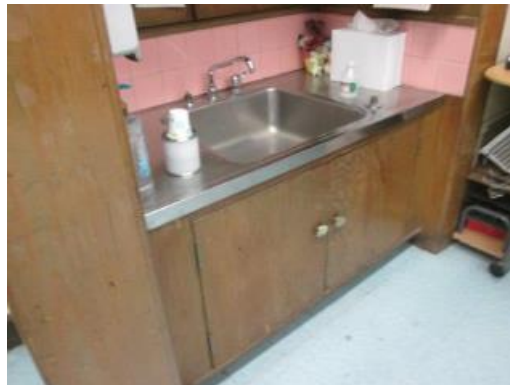
Aged Cabinetry

Deficiency	Category	Qty	UoM	Priority	Repair Cost	ID
Room has insufficient writing area.	Educational Adequacy	1	Ea.	3	\$4,563	Rollup
Replace Cabinetry In Classes/Labs <b>Note:</b> The cabinets are in poor condition.	Capital Renewal	22	Room	4	\$266,643	17848
Room lacks an appropriate refrigerator.	Educational Adequacy	1	Ea.	5	\$8,556	Rollup
<b>Sub Total for System</b>		<b>3</b>	<b>items</b>		<b>\$279,762</b>	
<b>Sub Total for Building 01 - Main Building</b>		<b>65</b>	<b>items</b>		<b>\$4,619,040</b>	
<b>Total for Campus</b>		<b>76</b>	<b>items</b>		<b>\$5,515,596</b>
